Property Inspection Report

1234 Example Lane, Anywhere, Texas 00000
Inspection prepared for: John & Sandy Sample
Date of Inspection: 8/15/2014

PROPERTY INSPECTION REPORT

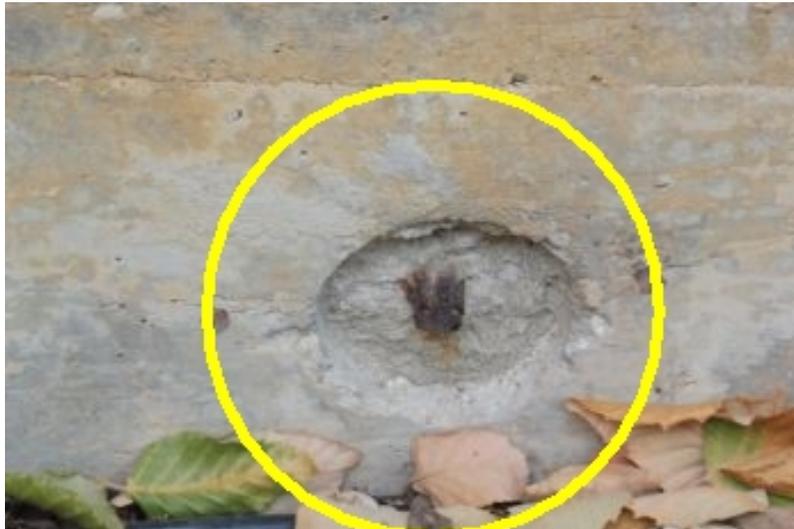
A.3. Post tension cable live ends are exposed and should be covered with a non shrink type grout or other product to prevent excessive rust or failure of the cable.

Post tension cable live ends are exposed and should be covered with a non shrink type grout or other product to prevent excessive rust or failure of the cable.

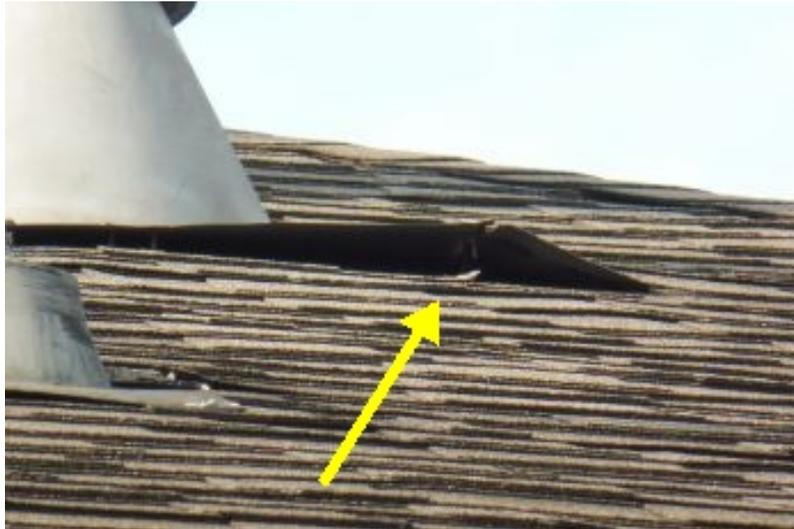
C.3. Lower side of flashing is not sealed down at one or more locations. wind driven rains may allow water penetration.

Lower side of flashing is not sealed down at one or more locations. wind driven rains may allow water penetration.

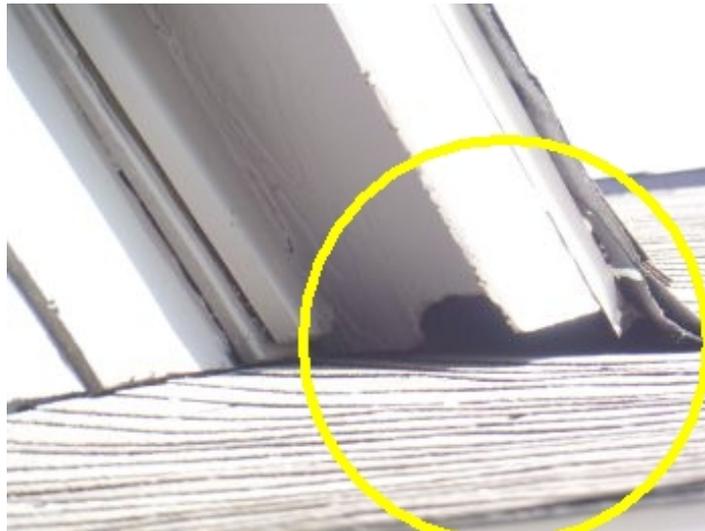
D.3. Seal all open roof eave ends or soffit cuts including eave terminations at brick or stone walls. These areas can allow animal activity into the attic.

Seal all open roof eave ends or soffit cuts including eave terminations at brick or stone walls. These areas can allow animal activity into the attic.

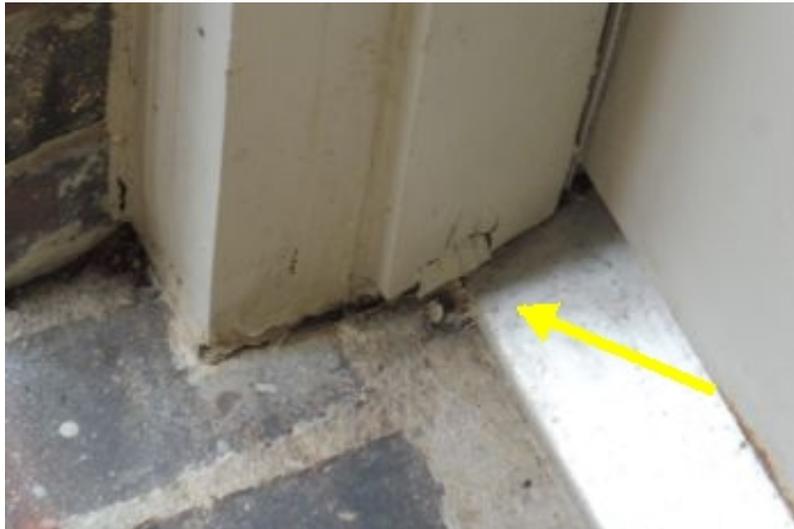
G.2. Wood rot or other damage appears present at the bottom of one or more exterior door frame areas.

Wood rot or other damage appears present at the bottom of one or more exterior door frame areas.

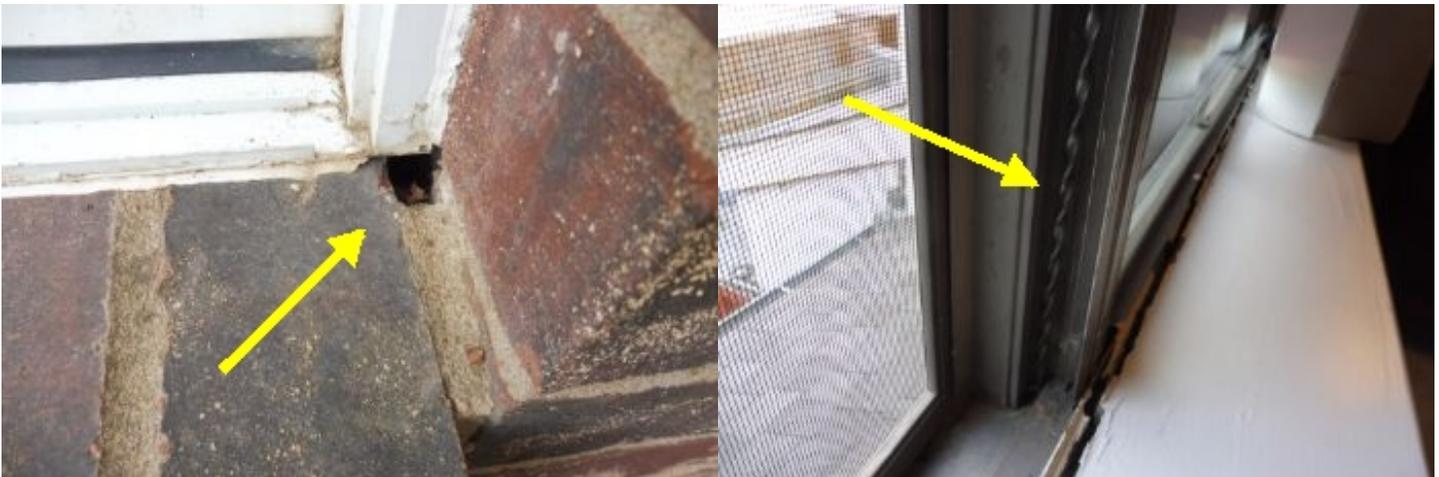
H.1. Re-mortar and seal all open areas of soldier bricks under exterior windows. These open areas can allow water penetration or insect access inside the wall.

H.2. One or more window springs are damaged or sprung and window will not open or stay open. These were marked with a black X on the window frame. Living room

Re-mortar and seal all open areas of soldier bricks under exterior windows. These open areas can allow water penetration or insect access inside the wall.

One or more window springs are damaged or sprung and window will not open or stay open. These were marked with a black X on the window frame. Living room

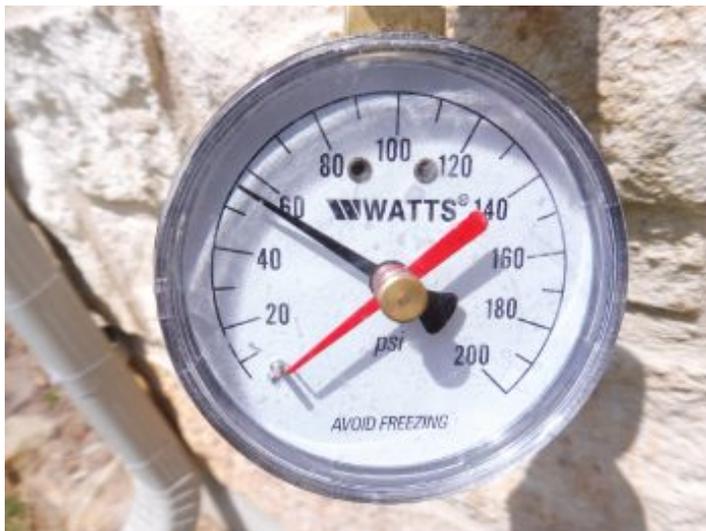
Water pressure was observed to be 55 PSI at time of inspection.

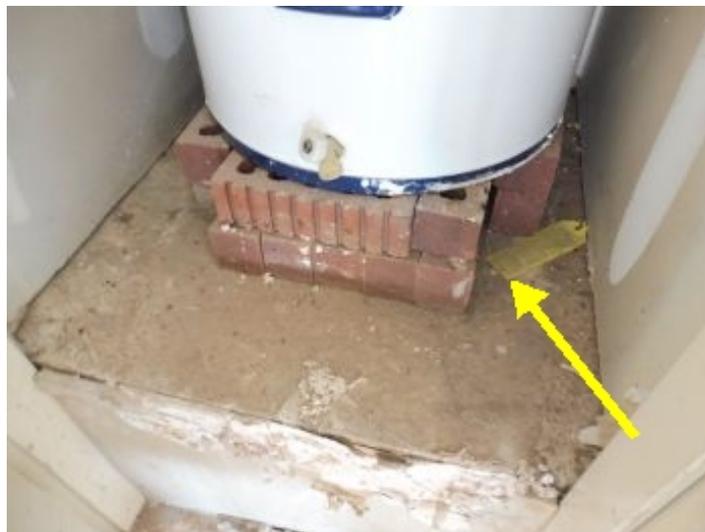
C.1. Unit/s are located in the house or garage without an overflow drain pan. Should the water heater/s leak there is a significant risk of water entering the home and causing damage.

Unit/s are located in the house or garage without an overflow drain pan. Should the water heater/s leak there is a significant risk of water entering the home and causing damage.

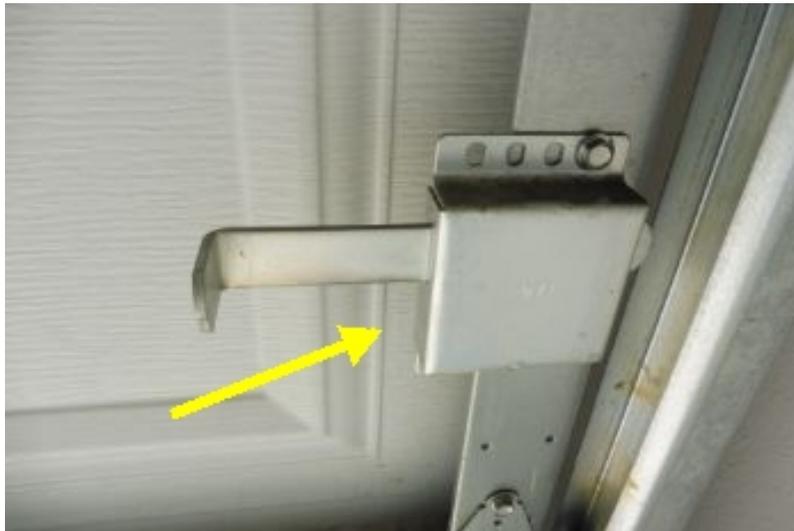
G.1. Manual door locks should be removed or disabled when an electric door opener is present to prevent future damage or injury.

Manual door locks should be removed or disabled when an electric door opener is present to prevent future damage or injury.

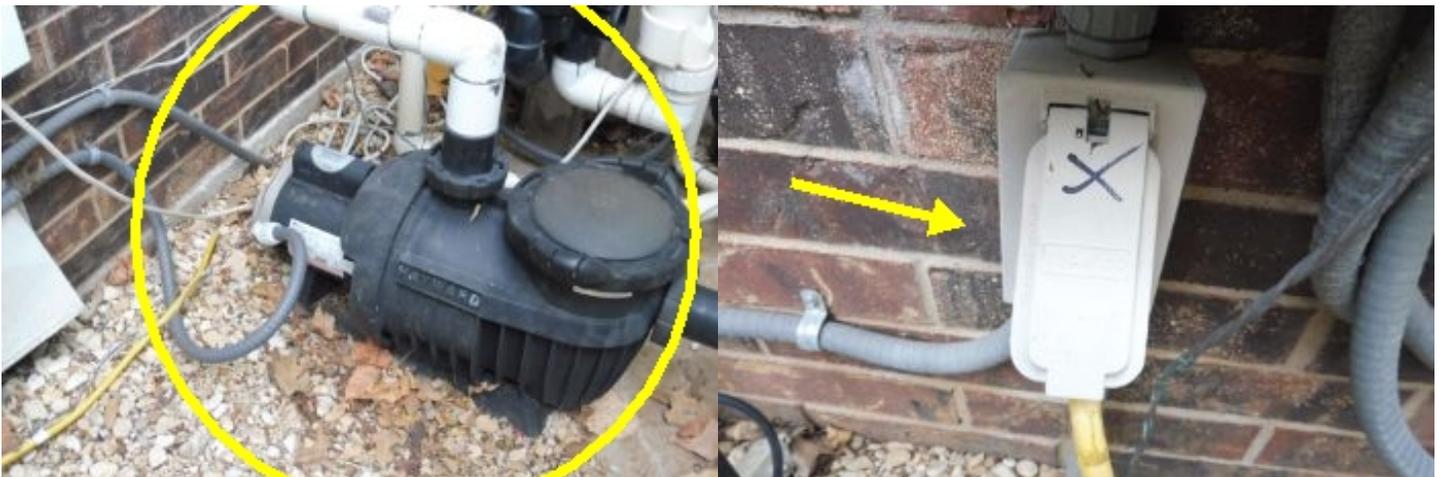
B.4. Water leaks were observed in the area of the pool motor/s and equipment and should be repaired.

B.5. GFCI protection did NOT operate properly when tested with a simulated short.

Water leaks were observed in the area of the pool motor/s and equipment and should be repaired.

GFCI protection did NOT operate properly when tested with a simulated short.
